SUCCESS STORY NUMBER M07: NETWORK BRINGS EXPERTS TOGETHER FOR MINING REPAIR – *Welding keeps largest NSW gold producer on target*

Cadia Hill, a member of the WTIA's NDNP Mining Industry Sectoral Project, approached WTIA to consult on repairs to a MP1000 crusher cone head being carried out for them by Camco Engineering in Perth, WA. With Welding Engineers based around Australia, WTIA was well placed to be able to offer the expertise.

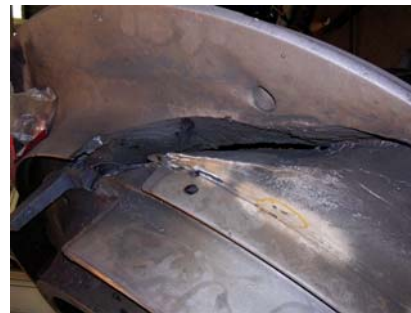
The cone head was found to have a major fatigue crack in the head of the casting, as well as general wear and several internal fatigue cracks.

One section of the crack was excavated to 50% of its length, where it was found the crack then ran out at various angles and eventually through the full depth of the unit. It was established that the crack was in fact over 800 mm long.

There was evidence of a defect in the body of the casting that was believed to be the likely cause of the fatigue crack. The challenge was to execute an effective, reliable and cost efficient repair to the unit, and to get it back into service.

Detail of fatigue crack in the cone head

Working with Camco staff, a welding procedure was developed for the repair of the major crack as well as the smaller radiating ones. Considering the size of the crack, it was necessary to conduct post weld heat treatment (PWHT), especially as pad welding would be required after the initial repair. Pad welding is used to build up a component back to its original thickness and integrity. Further PWHT was conducted after the pad welding, and the final inspection and testing of the repair show that it had been completely successful.

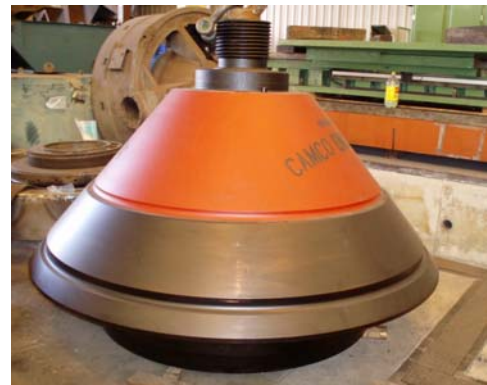
Fully restored cone head
