1. SCOPE

This Note provides information on cracking in welded fire-tube boilers, including location of cracks, failure modes, causes, detection, repair and prevention. The necessary actions to be undertaken when cracking is suspected or confirmed are provided. The information provided is based on global experience.

NDNP TECHNOLOGY DIFFUSION ACTIVITY # 27	  Welding Technology Institute of Australia ABN 69 003 696 526	Document No: 9.4.4 – QR - 002
	NATIONAL DIFFUSION NETWORKS PROJECT TECHNOLOGY QUESTIONNAIRE Pressure Equipment Industry Group “Cracking in Fire-tube Boilers”	Revision No: Rev 0
		Page 1 of 2 Date: 18 Nov 2005

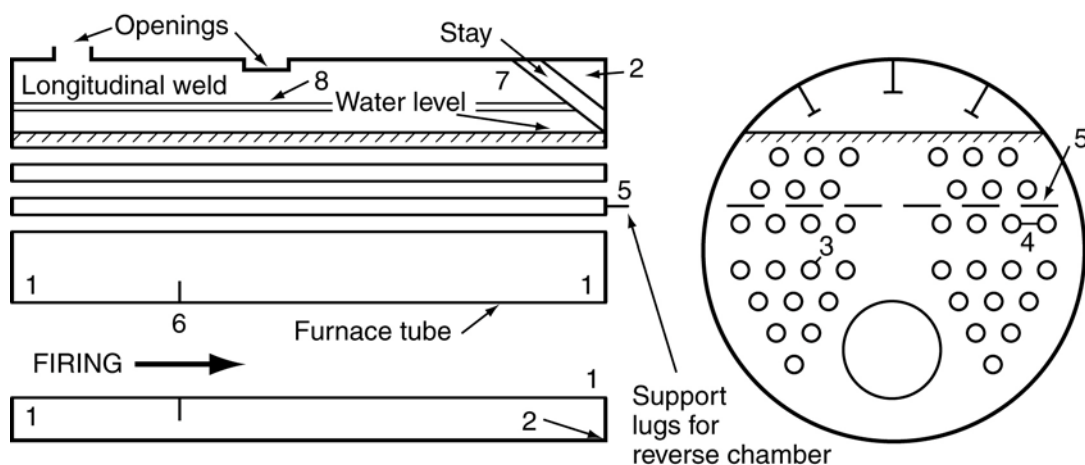
Figure 1. Fire-tube boiler showing eight potential cracking locations

Of the eight potential crack locations shown, the major occurrence is furnace tube cracking adjacent to the tube plate weld identified as number 1 in Figures 1 and 2. Other locations of the boiler also exhibit cracking particularly cracking associated with fire-tubes identified as numbers 3 and 4 in Figures 1 and 2.

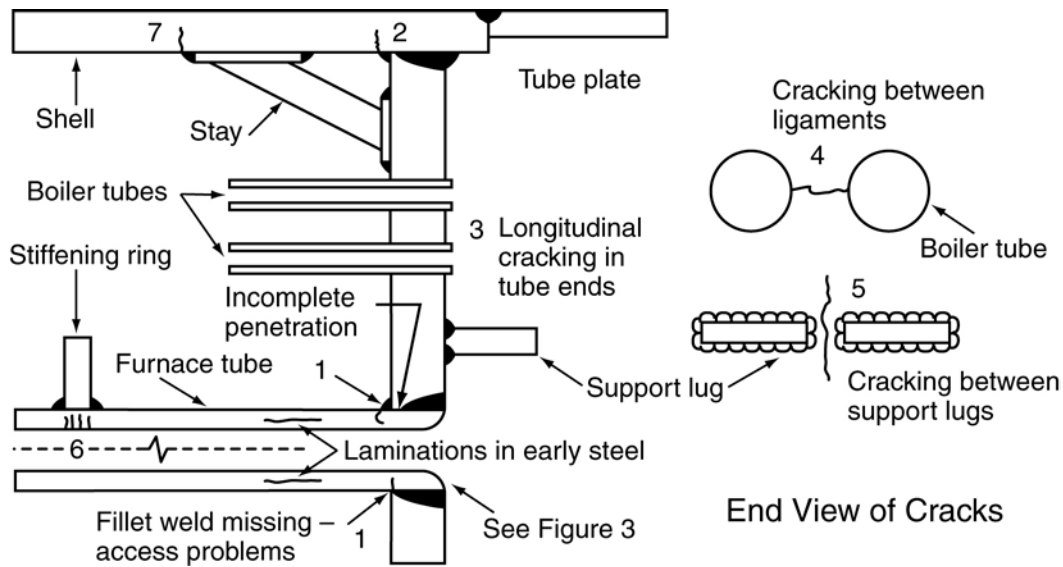
Figure 2. Details of crack sites

Crack Location	Crack Description
1	Furnace tube circumferential cracking at tube plate weld
2	Shell circumferential cracking at tube plate and shell weld
3	Tube end cracking
4	Tube plate ligament cracking between boiler tubes
5	Tube plate cracking at or between reversal chamber support lugs
6	Furnace tube cracking at stiffening ring
7	Shell cracking at gusset stay welds
8	Shell cracking in longitudinal seam weld

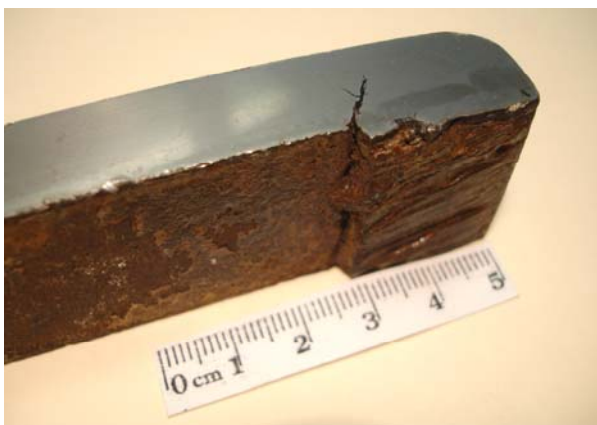
Figure 3. Typical furnace tube cracking

Cracking occurs in a highly localised area in the furnace tube on the water-side of the boiler. The cracks originate at the root of the furnace tube to tube-plate weld. Cracking can occur at both front and rear ends at any position around the furnace tube plate but cracking is most common at the bottom of the tube plates. Cracking generally occurs in the furnace tubes as they are thinner, and hence more highly stressed than the tube plate (see Figure 3).

The failure mode is corrosion fatigue. Slight corrosion occurs as a result of contact with the water. Fatigue arises from thermal cycling and pressure cycling. The primary causes of furnace tube cracking are a combination of:
