WTIA National Diffusion Networks
Project (NDNP) funded by the
Federal and State and Territory
Governments and industry

SUCCESS STORY NUMBER BC04: BETTER WELDING PROCEDURES HELP SCRAP STEEL RECYCLING – *Improved repair methods for molten steel ladles help the steel recycling process, and the comfort of the people involved*

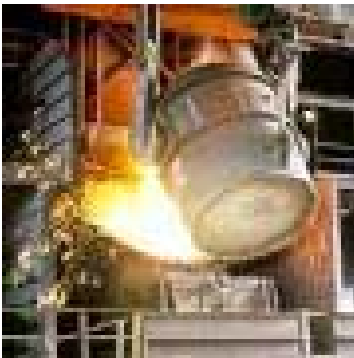
The melt-shop ladles are built to the guidelines of AS 1210, the Unfired Pressure Vessel Code as they have to cope with the extreme high temperature (~ 1600 Deg C) of the molten metal. They have a refractory lining that is regularly maintained and replaced.

Melt-shop ladles

Secondly, under hot metal erosion conditions, the refractory linings are prone to failure, especially cracking around the base assembly and ladle openings with wash-out of the lining leading to subsequent hot metal wash damage to the steel structure of the ladle and in some cases, cracking. These structural failures are repaired using flux cored gas shielded arc welding.

When looking for improved weld procedures for repair of mechanical damage, wash-out and cracks, Glen took into account that the large volume of weld metal deposited traditionally leads to unwanted distortion of the ladle base.

New repair procedures were designed to not only repair the ladles, but distortion control measures were implemented to counteract this unwanted side effect.
