WINS!

SUCCESS STORY NUMBER MS05: LASER TRIMMING OF PLASTIC PANELS – Analysis of mirror contamination improves productivity for SA components manufacturer

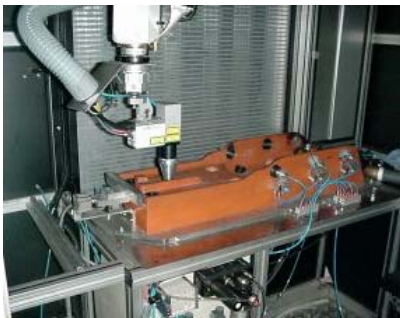
*diode
laser
interacting
with
plastic
parts in a
fixture*
