SUCCESS STORY NUMBER W06: WELDING EXPERTISE, AND SOME LOCAL KNOWLEDGE, GET PUMP BACK IN SERVICE – *WTIA Engineers help SA Water successfully complete a difficult repair job on an austenitic cast stainless steel pump*

Swan Reach-Stockwell Pipeline

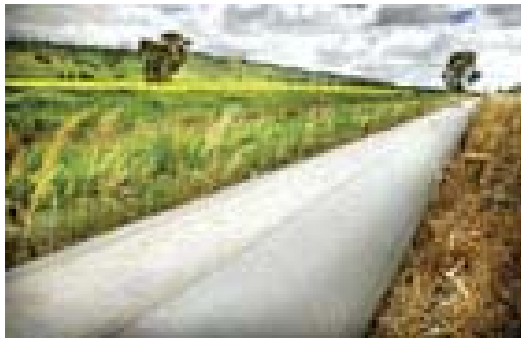
WTIA's Technology Manager Greg Terrell, based at CSIRO premises in Adelaide, was called in to assist with the repair of an extremely large pump serving the pipeline. The pump, originally manufactured in 1962, weighed in at more than half a tonne, and measured some 2.5 by 1.5 by 1.5 metres.

The cast iron pump body was found to be suffering corrosion and cracking through the wear and tear of its work. With a nine-month lead-time to source a replacement pump, it was decided by SA Water to undertake repairs.

A special Welding Procedure Specification was drawn up by Greg incorporating the use of nickel electrodes and stress relief by peening. Most weldment surfaces are under tension due to shrinkage after being exposed to welding heat. Peening can reduce tensile stress by inducing compressive stress on the part. In this application peening was done by using mechanical impact hammers.

A critical element in the repair procedure was the requirement to pre-heat the entire pump casing, and to maintain the temperature over the 3-day duration of the repair – not such an easy job with a component of this size.

The solution was provided by SA Water's tradesmen, to wrap the entire piece in aluminium foil-coated insulation, and to apply heat using a domestic fan heater. Simple, but extremely effective.

At the end of the repair, the casing was subjected to a hydro-test that found nearly all of the 40 cracks had been successfully repaired. To safeguard the future integrity of the seal, the unit was lined with a composite, and then returned to active service.
